**United States Environmental Protection Agency
EPA New England
One Congress Street, Suite 1100
Boston, MA 02114-2023**

RE: October 2004 Monthly Report
1.5 Mile Reach Removal Action
GE-Pittsfield/Housatonic River Site

**GE-Pittsfield/Housatonic River Project 1.5 Mile Removal Action
Pittsfield, MA**

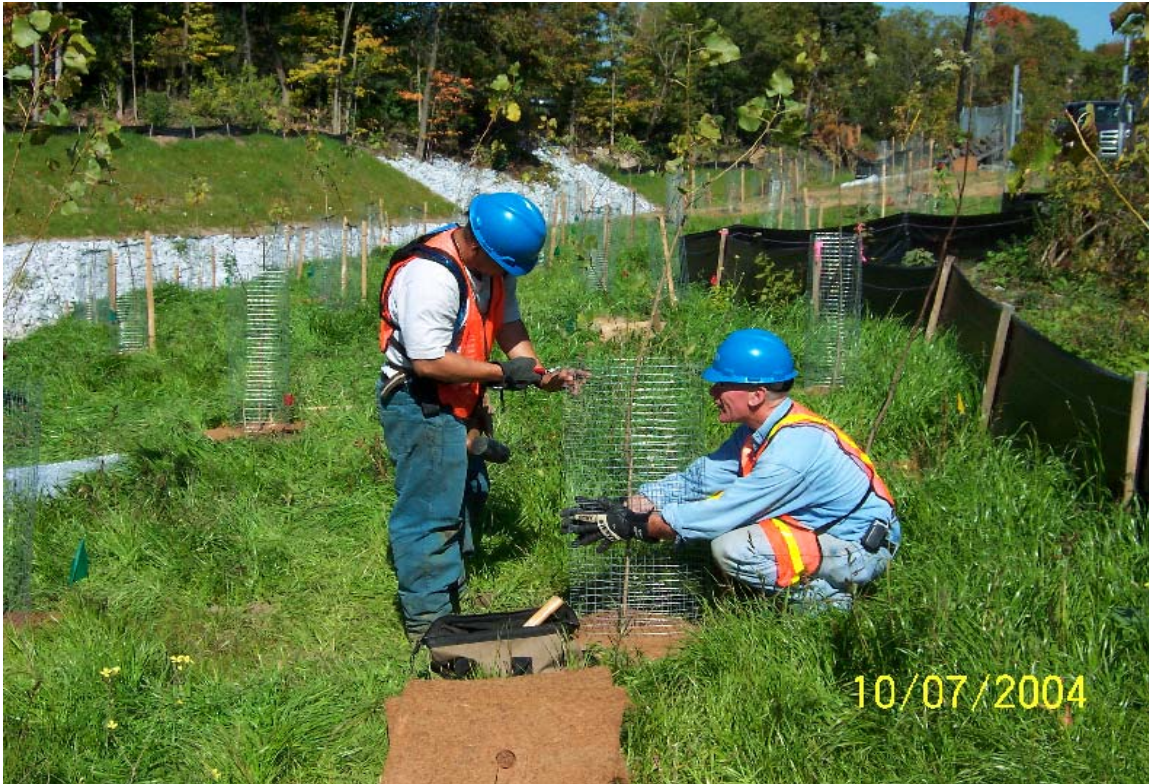
Photograph 1– Cell 17E Tree Planting Activities

Also during the fourth week of October the fall tree and shrub planting activities in Cells 16, 17, 18E and 19E were completed. In addition the installation of three white pine trees on Parcel I8-4-6 was completed and maintenance work was performed on the arborvitaes on Parcel I8-23-6.

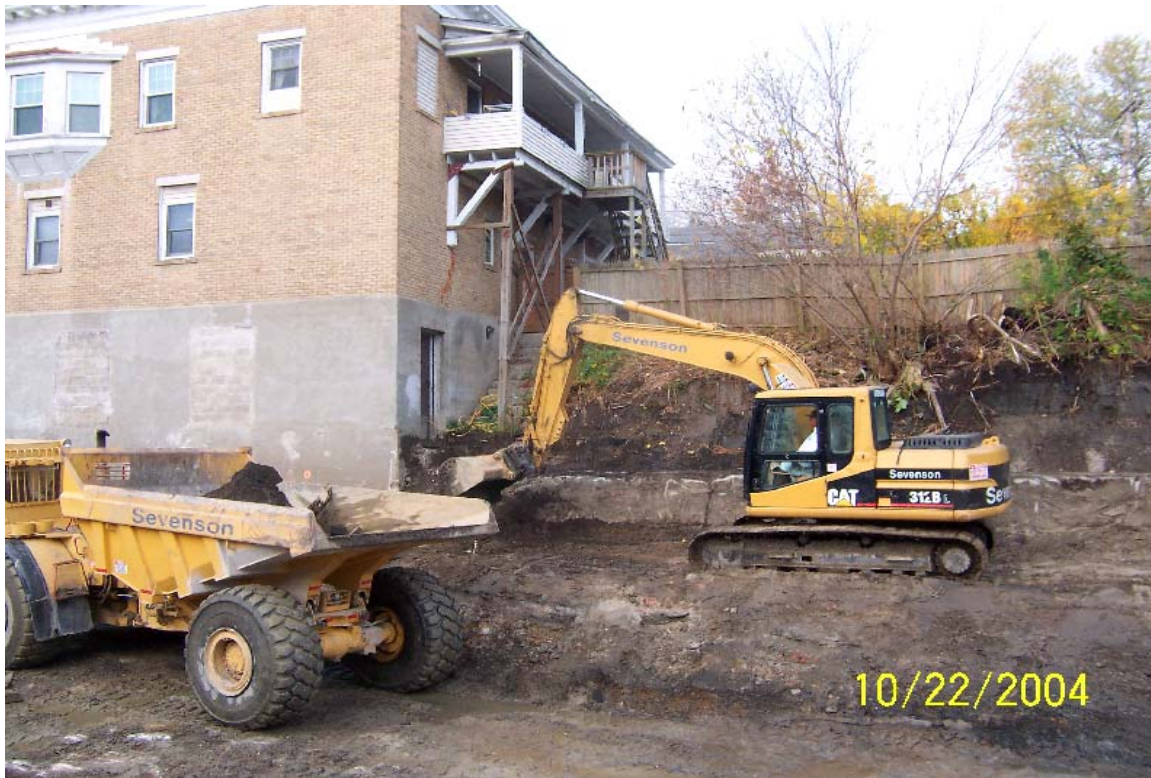
Photograph 3– Riverbank Excavation Activities in Cell 22W

During the fourth week of October, the survey contractor continued the delineation of non-TSCA and TSCA excavation areas in Cells 20W, 21W and 22W. The access ramp into the riverbed from Parcel I7-21-3 riverbank was re-built. The dewatering activities continued in Cells 20, 21 and 22. Once the dewatering was completed, riverbank and riverbed excavation activities in Cells 20W, 21W and 22W were initiated. The excavated material was placed into an ADT, which transported and dumped the material into a roll-off box located in the river channel in Cell 20. The material was then loaded into dump trucks by a long stick excavator located on the load out area on Parcel I7-21-3. The excavated TSCA material was transported to Area 64A and Building 63 stockpile management areas. The non-TSCA riverbank material pre-characterized for off-site disposal was transported to Area 64D and the non-TSCA material not characterized for off-site disposal was transported to Area 64B and Building 65 stockpile management areas.

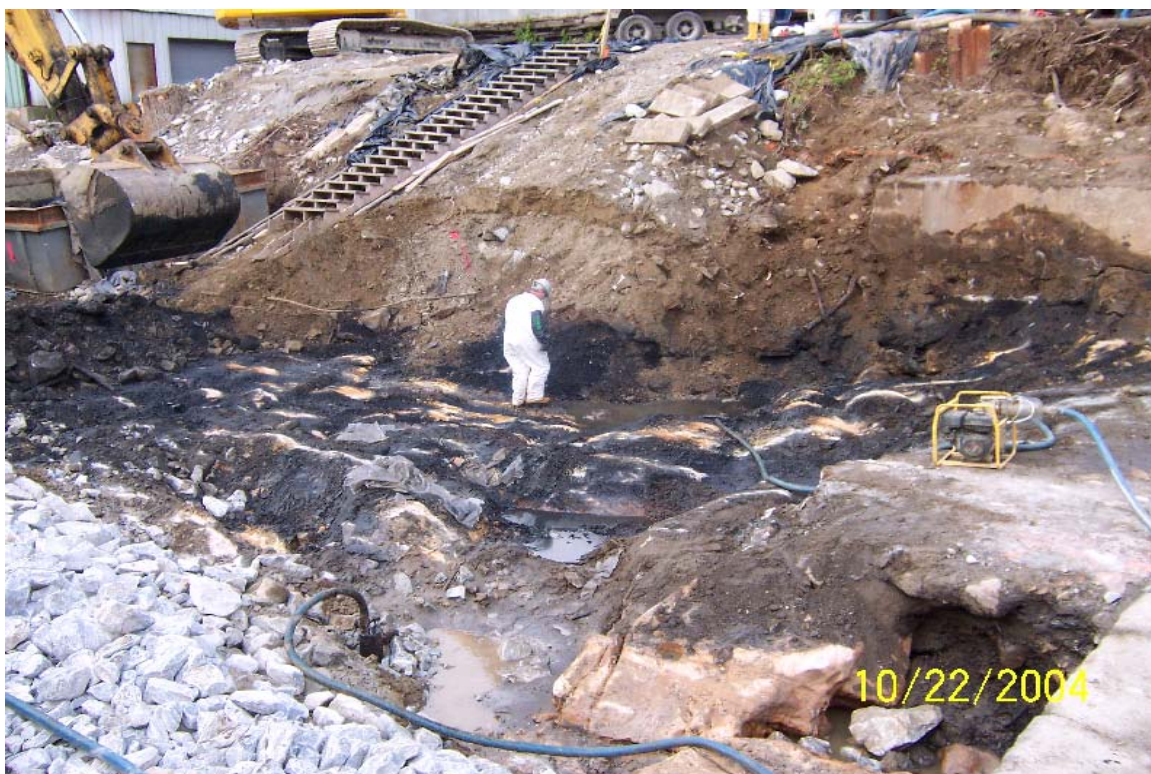
Photograph 4–Cell 20W Excavated Riverbed ready for Power Washing

Bedrock was encountered in the entire Cell 20W and approximately 60% of the riverbed in Cells 21W and 22W. In addition to the standard excavation equipment, a small track excavator was used to access and remove the sediment from the areas of the river bottom where crevasses and depressions in the weathered bedrock were numerous. The high pressure power washing of bedrock to remove any loose sediment was initiated in Cells 20W, 21W and 22W. High pressure power washing of bedrock was supplemented with a vacuum truck to remove any residual sediment from the bedrock. All water generated during the power washing was diverted to the water treatment system. All the residual sediment material was collected into roll-off boxes located in the riverbed and subsequently transferred to the water treatment system modutank.

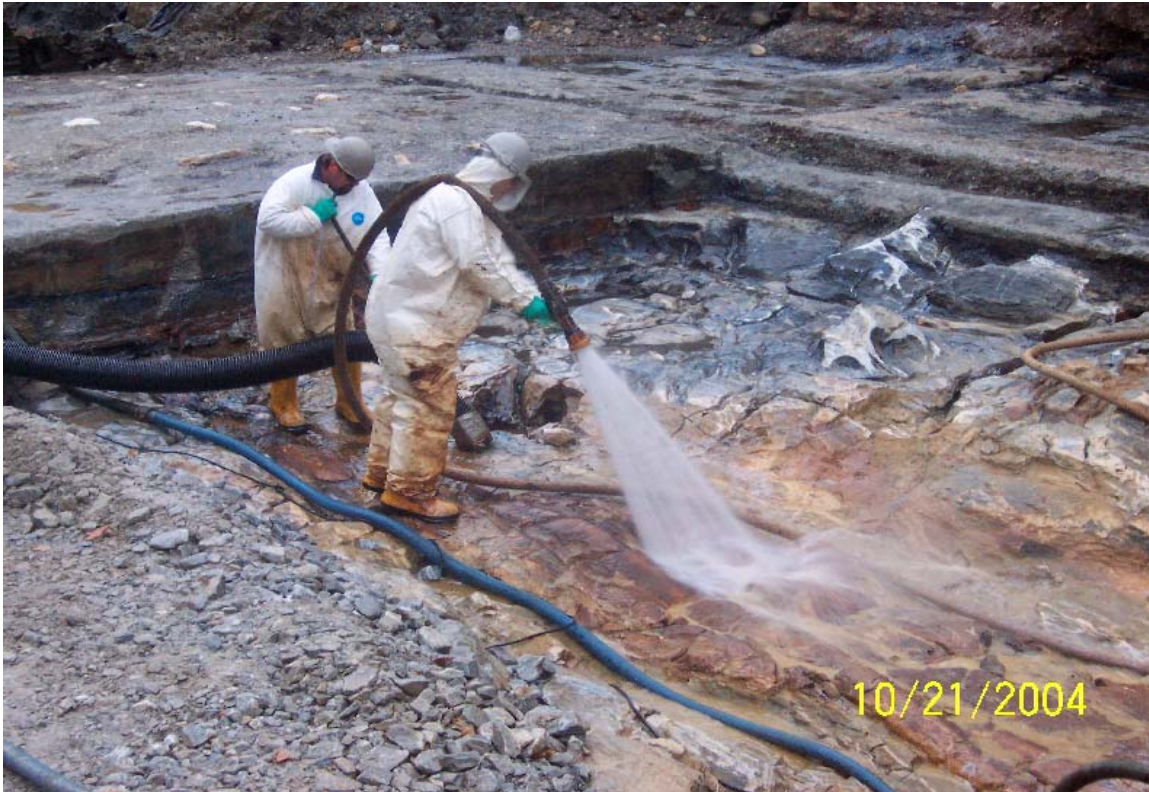
Photograph 5– Cell 20W Riverbed Power Washing

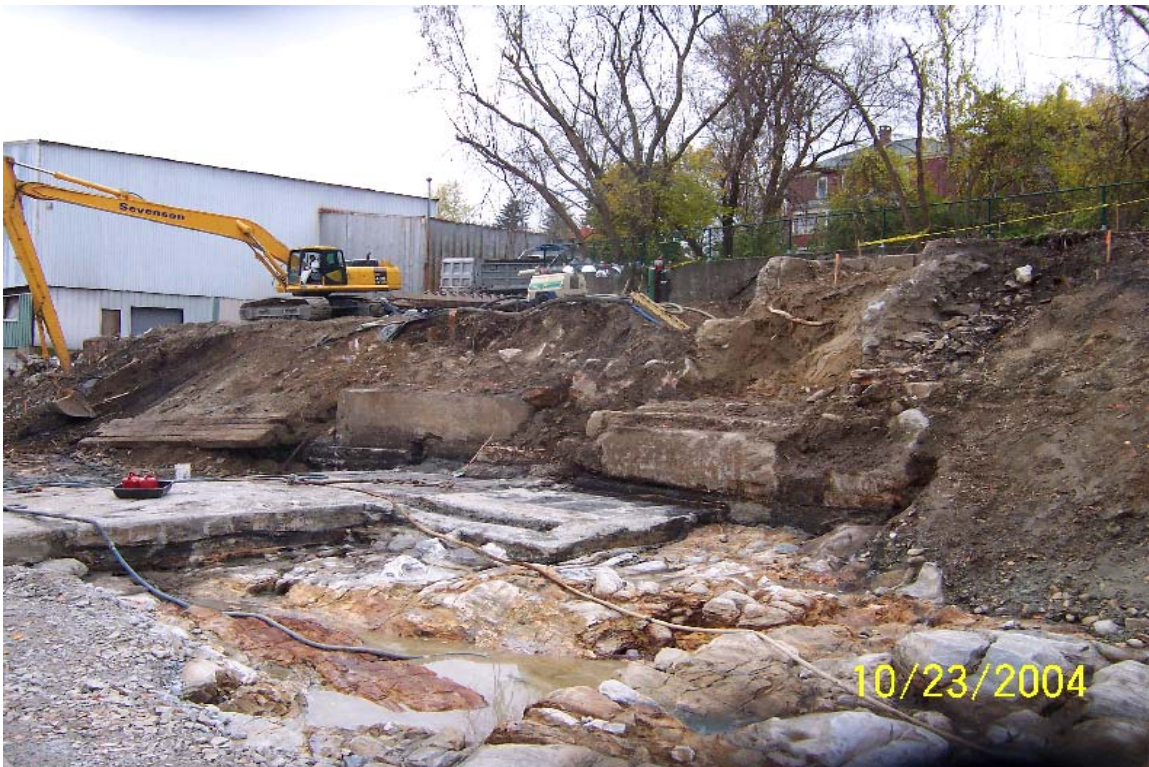
Photograph 6– Cell 20W Dam Foundation and Washed Bedrock

Also, during the excavation of the riverbed sediment in Cell 20W, around the former dam foundation, located adjacent to Parcel I7-21-5 NAPL was encountered. The excavation of the NAPL-impacted area extended approximately to 4 feet in depth. The Cell 20W NAPL-impacted material was excavated and transported to the Building 68 stockpile management area. Bedrock was encountered in the entire river bottom in Cell 20W where NAPL was present. In addition to the standard excavation equipment, a small track excavator was used to access and remove the NAPL and the sediment from the areas of the river bottom where crevasses and depressions in the weathered bedrock were numerous. The high pressure power washing of bedrock to remove any NAPL staining and loose sediment was necessary in Cell 20W. High pressure power washing of bedrock was supplemented with a vacuum truck to remove any residual NAPL and sediment from the bedrock. All of the water and the free flowing NAPL from the excavation areas were diverted to the water treatment system. It was observed that the depression where the NAPL was found had several bedrock fractures; therefore, there was the potential for NAPL to seep out into the restored riverbed in the future. The depression was encapsulated with a grout cement mixture. Filter stone and 18-inch riprap was then placed into the NAPL hole to bring it up to grade.
